MEMO TO FILE

The following information,	Photos	, has been
separated from the rest of the		
site, Schree-Morehead Ch	OMID # TXDOO73	334659 , because
the material could not be sto	red at the Federal	Records Center due
to certain storage restriction	ns.

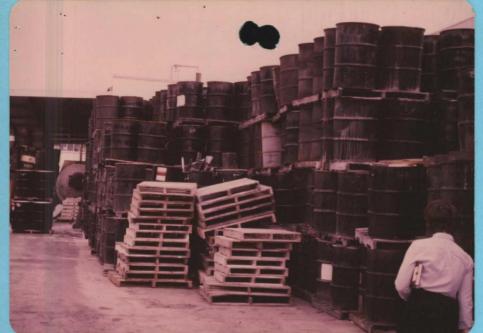
side of property. Note drainage conduits in cement slab.

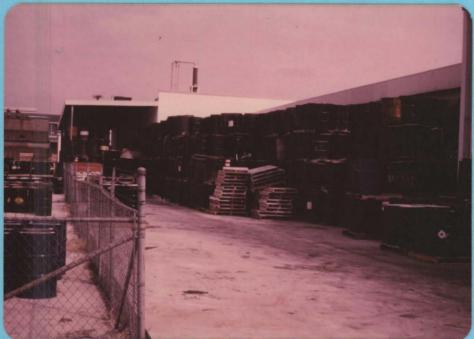
F o 7
Photographer / Witness
Barry Nash
Date / Time / Direction
2-27-81/1045/ CLOSEUP
Comments: Leakage from drums.
As material comes in contact
with air, solvent evaporates and
the material turns to a
rubbery consistency. Spills do
rubbery consistency. Spills do not travel far.
PHOTO 8 Photographer / Witness
Barry Nach
Date / Time / Direction
2-27-81/1055/ NNE
comments: Drum storage on
west side of plant
property. Fenced area
to left is Koppers Paints.
Photographer / Witness
Date / Time / Direction
